Searls v. Johns Hopkins Hospital Investigation

Clyde C. Richard, Ph.D., P.E.
Mechanical Engineer

February 4, 2015

CED Case No. 10707.1

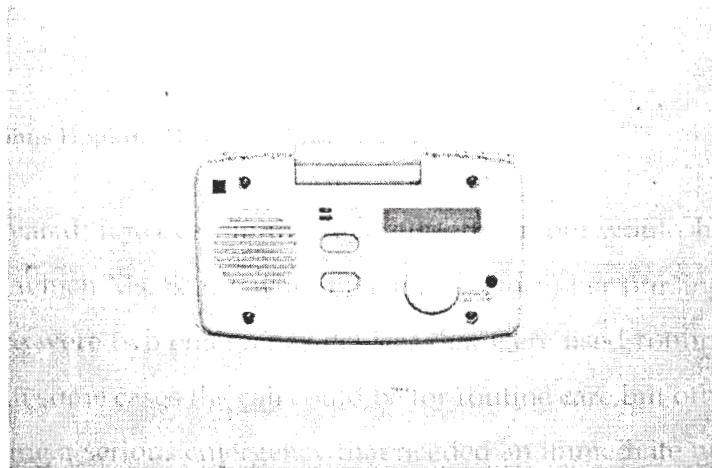
Figure 1: Code machine located within the room

The equipment in Figure 1 and Figure 2, which was located in Halsted 8, was designed to communicate to nurses through both auditory and visual signals. When the emergency equipment was activated, an auditory signal was sounded to inform nurses that an emergency situation was occurring. A light was also activated on a sign above the doorway to again inform nurses that there was a situation requiring immediate assistance (Figure 3).

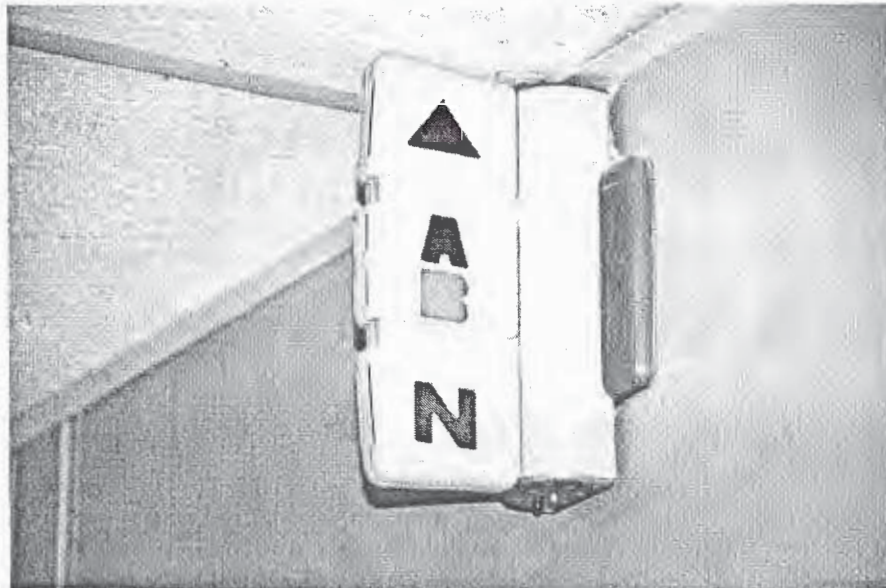
Figure 3: Light monitoring system above doorways in Halsted 8

During CED's inspection, the nurse's station located within Halsted 8 was inspected. This nurse's station was located at the end of a long hallway of patient rooms located on either side of the hallway. From the nurse's station it was not possible to see the light monitoring system sign (Figure 3) located above a single patient room in the long hallway. Auditory signals therefore would be necessary to make nurses aware of a patient emergency/request. While walking through Halsted 4, which was a floor reported to be similar to Halsted 8, it was also noted that not every above-door light could be seen from the end of the hallway even if a person was not within the nurse's station, but rather standing in the hallway and looking down the hallway. Various pieces of equipment in the hallway blocked the direct view of some of the above door lights.

ultimately impacting patient wellbeing. Signs above the doorway of patient rooms would also indicate if an emergency or patient need was ongoing. In Halsted 8, it was noted that a nurse could only see the sign above a single room from the clerk's station. An inspection of Halsted 4 indicated that it was difficult to see all of the above door signs from the end of the hallway, as equipment obscured the line of sight to some of the signs.

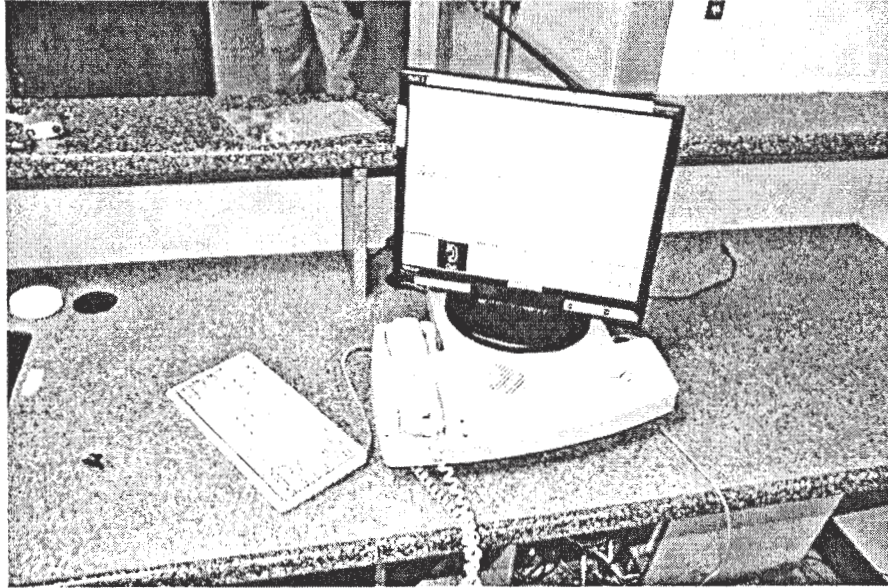
Figure 4: Call system located within the nurse's station

Although much of Halsted 8 was under renovation, the nurse's station in Halsted 8 still contained the nurse contact and call system. Upon the previously shown Code (Figure 1) or emergency pull cord (Figure 2) activation; this system would alert the nurse to a patient's need. The call system operated by an auditory

"beep" with a signal displayed on a screen (Figure 4).

The physiological monitoring system contained a monitor on which all patient information was displayed. This monitor was at the end of the hallway in the nurse’s station area. This system operated through an auditory signal consisting of a different number of “beeps” to signal an event present in one of the rooms. While one could determine alarms through watching the monitor, it would necessitate that they focus their full attention to viewing the monitor at all times. Sitting full-time in front of the monitor would prevent a nurse from completing other assigned tasks,
